INSPECTION REPORT

2183 SAMPLE PLACE

Inspection Date: Monday, June 4, 2007

Prepared by: Timo Pera

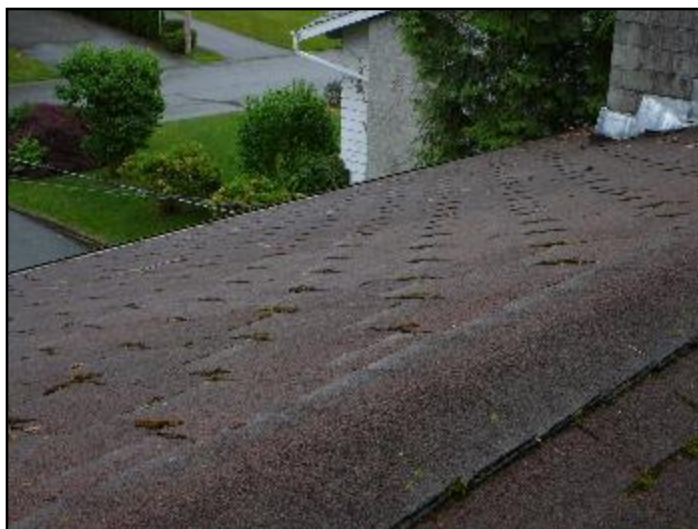
Sloped roofing \ Asphalt shingles

Condition: • [Near end of life expectancy](#)

Implication(s): Chance of water damage to contents, finishes and/or structure

nearing end of service life

Task: Replace

Time: Less than 2 years

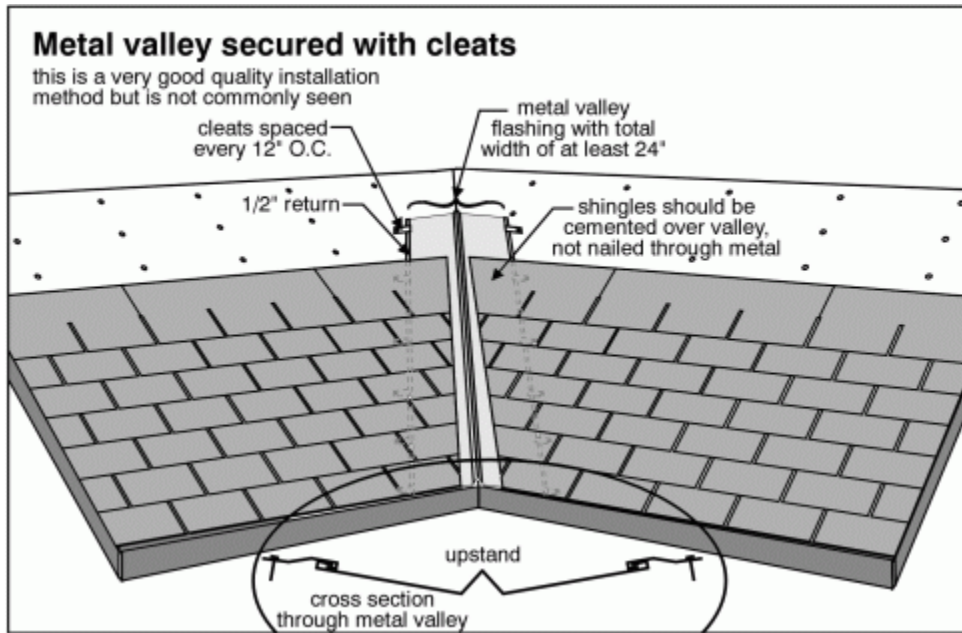
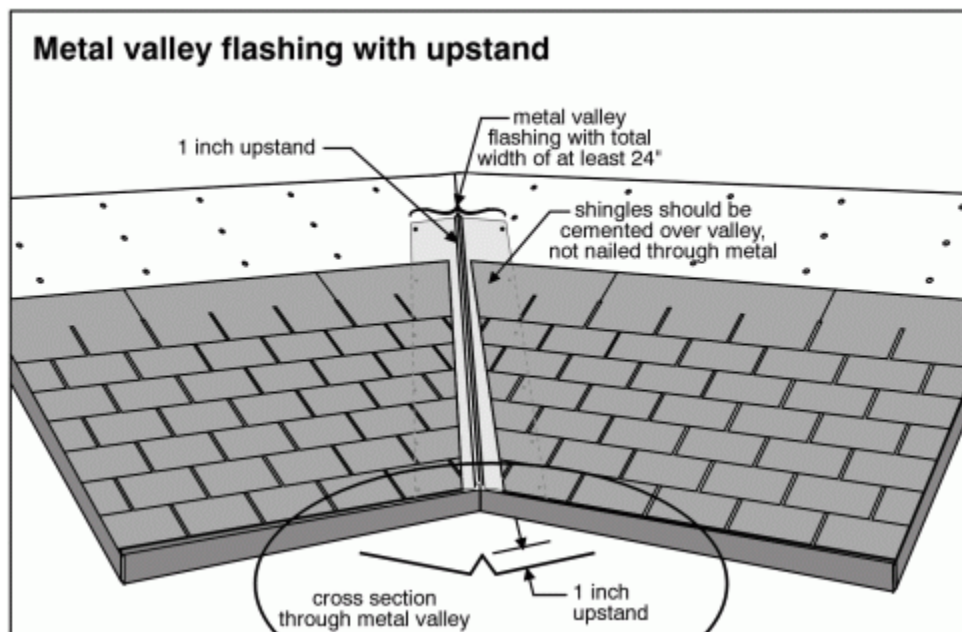
Sloped roof flashings \ Valley flashings

Condition: • [No upstand](#)

Implication(s): Chance of water damage to contents, finishes and/or structure

Task: Monitor

Time: Unpredictable

Note: Replace when new roof installed

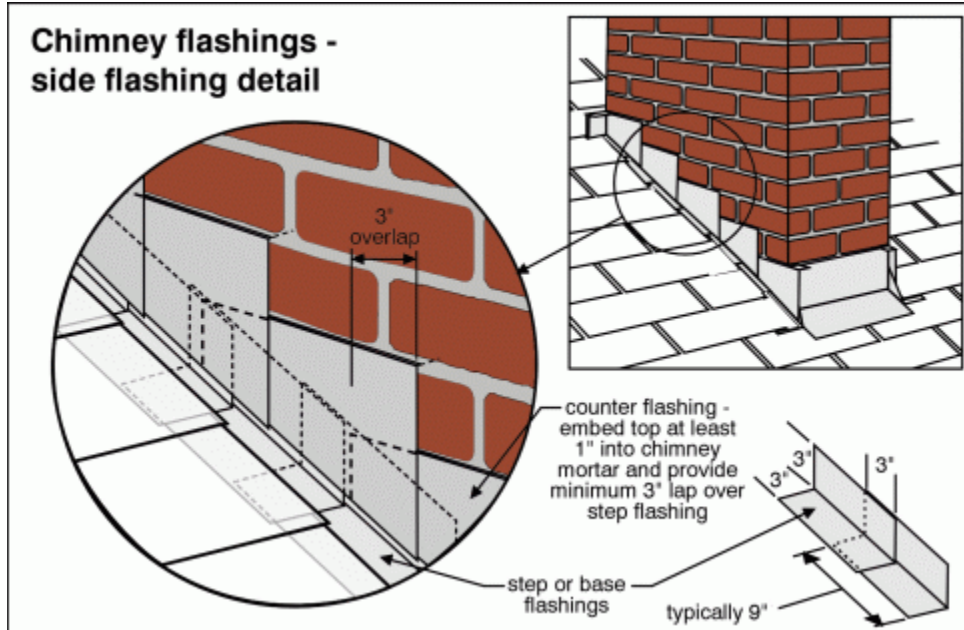
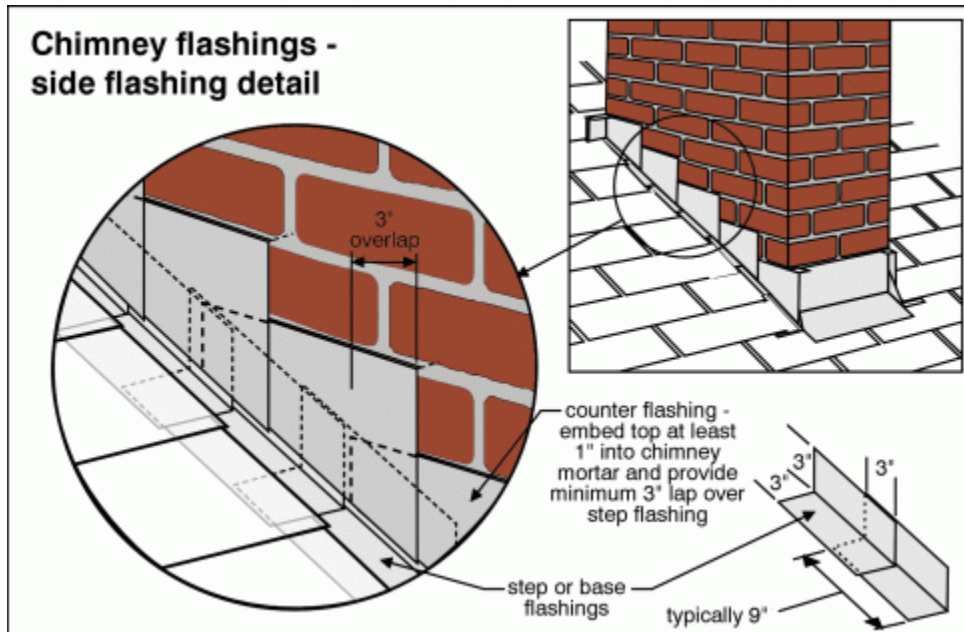
Sloped roof flashings \ Chimney flashings

Condition: • [Side flashings not set into shingles properly](#)

Implication(s): Chance of water damage to contents, finishes and/or structure

Task: Repair or replace

Time: Less than 1 year

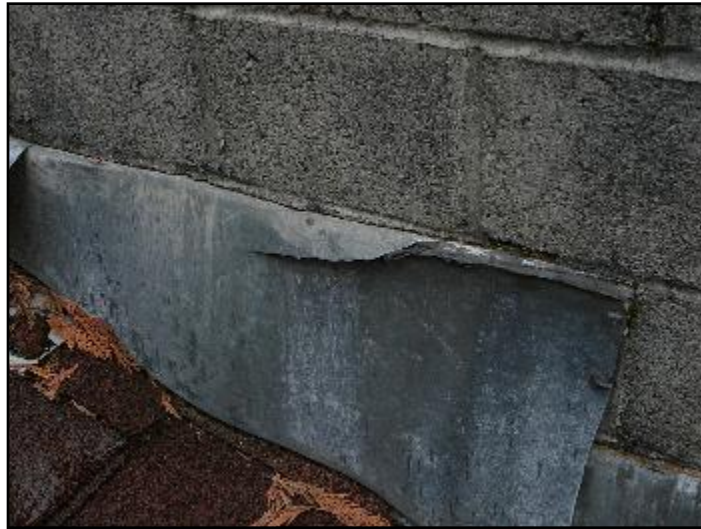
damaged- replace when roof replaced

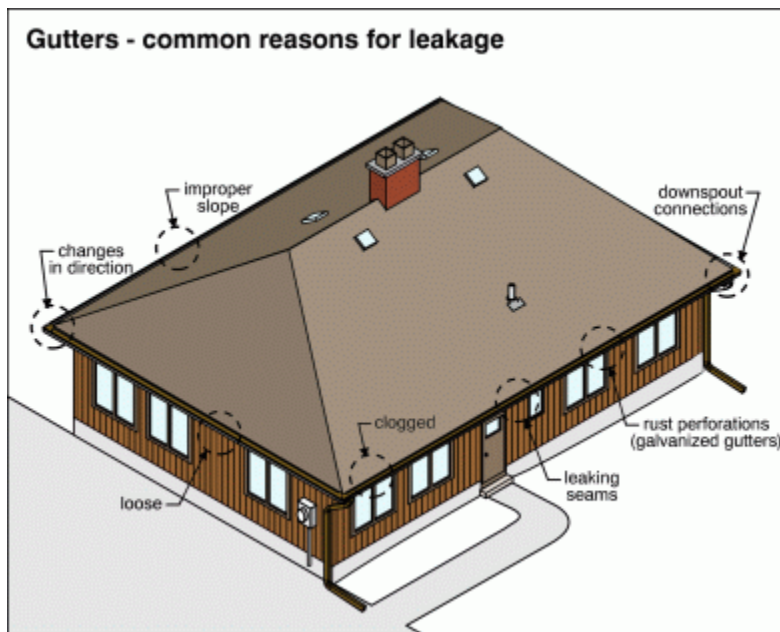
Roof drainage \ Gutters

- Condition:** • [Clogged](#)

Implication(s): Chance of water damage to contents, finishes and/or structure

Task: Clean

Time: Less than 1 year

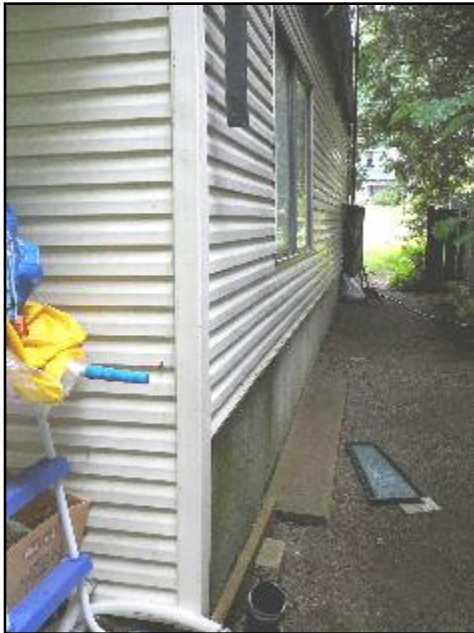
Roof drainage \ Downspouts

Condition: • [Not well secured](#)

Implication(s): Leakage

Note: Downspouts not connected to drain system

Task: Repair

Time: Immediate

add downpipe to connect to drain

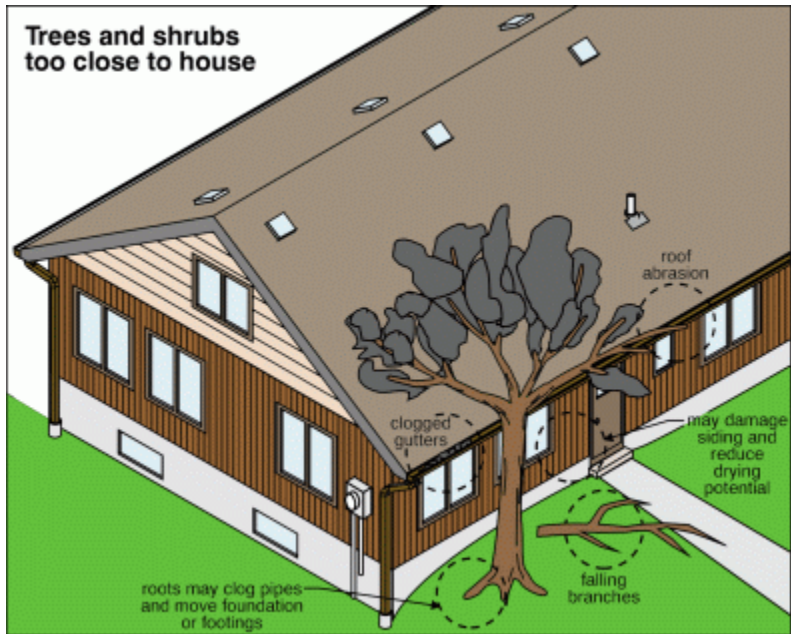
Landscaping \ General

Condition: • [Trees or shrubs too close to house](#)

Implication(s): Chance of water damage to contents, finishes and/or structure | Chance of pests entering house | Material deterioration

Task: Improve

Time: Less than 1 year

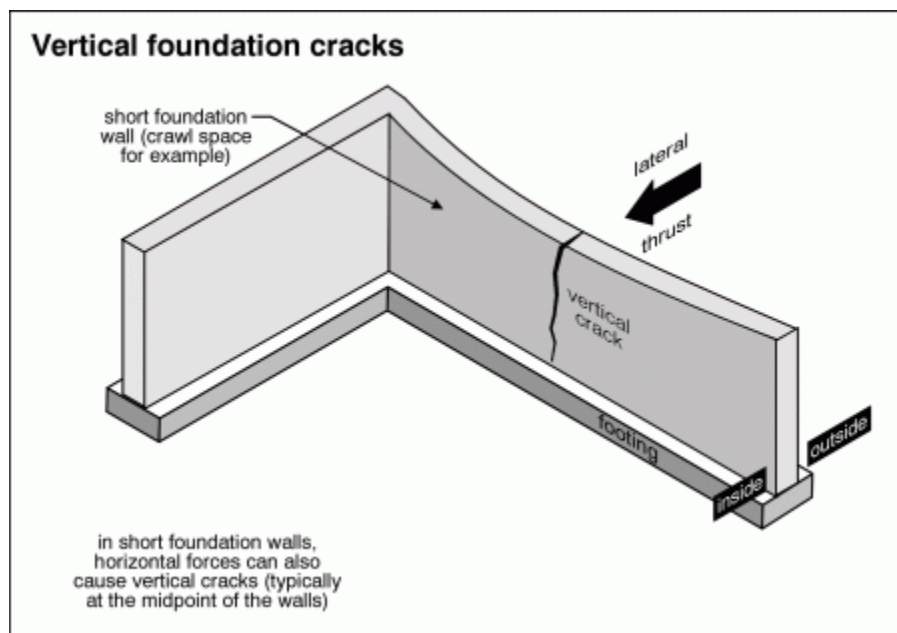
Foundations \ Foundation

Condition: • [Cracked](#)

Implication(s): Chance of water damage to contents, finishes and/or structure | Weakened structure

Task: Monitor

Time: Unpredictable

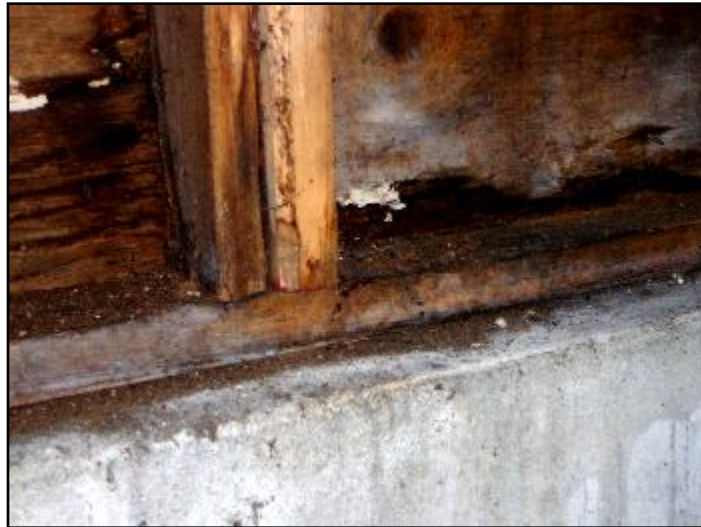
Walls \ Wood frame walls

Condition: • [Rot, insect or fire damage](#)

Implication(s): Weakened structure

Location: Rear Garage

Task: Repair or replace

Time: Less than 1 year

repair

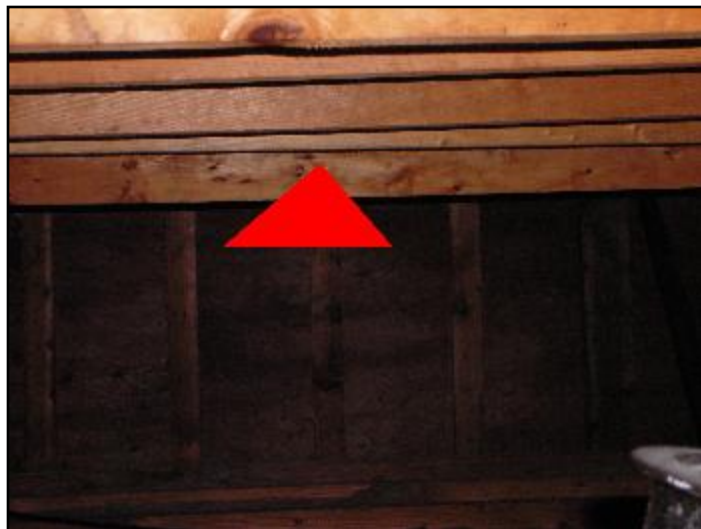
Roof framing \ Collar ties/rafter ties

Condition: • [Mechanical damage](#)

Implication(s): Weakened structure | Chance of structural movement

Location: Attic

Task: Repair

Time: Less than 1 year

repair collar tie

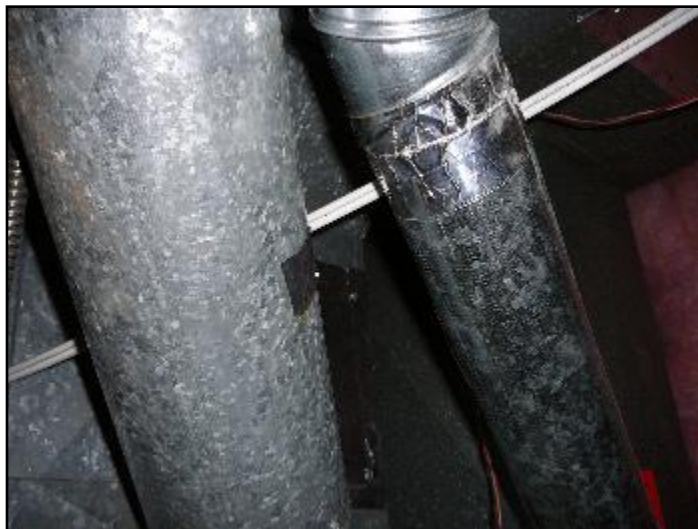
Distribution system \ Wiring - damaged or exposed

Condition: • [Too close to ducts, pipe, chimneys, etc.](#)

Implication(s): Electric shock | Fire hazard

Location: Basement Furnace room

Task: Improve

Time: Immediate

move wire - provide proper support

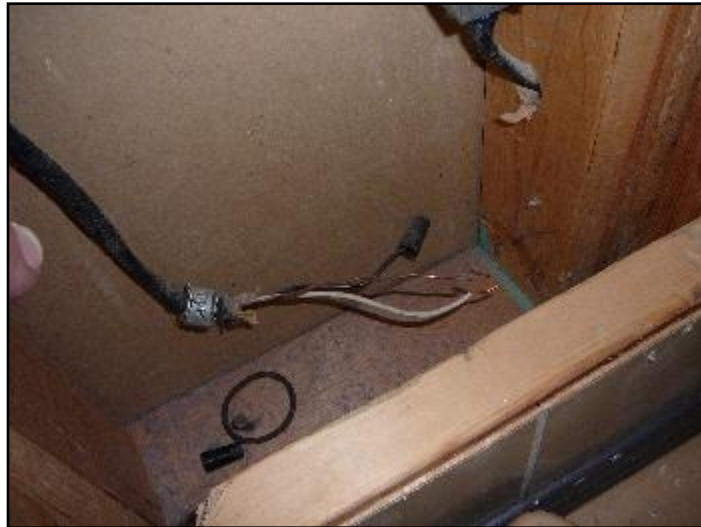
Distribution system \ Wiring - installation

Condition: • [Abandoned wire](#)

Implication(s): Electric shock

Location: Basement Bathroom

Task: Correct

Time: Immediate

provide proper termination

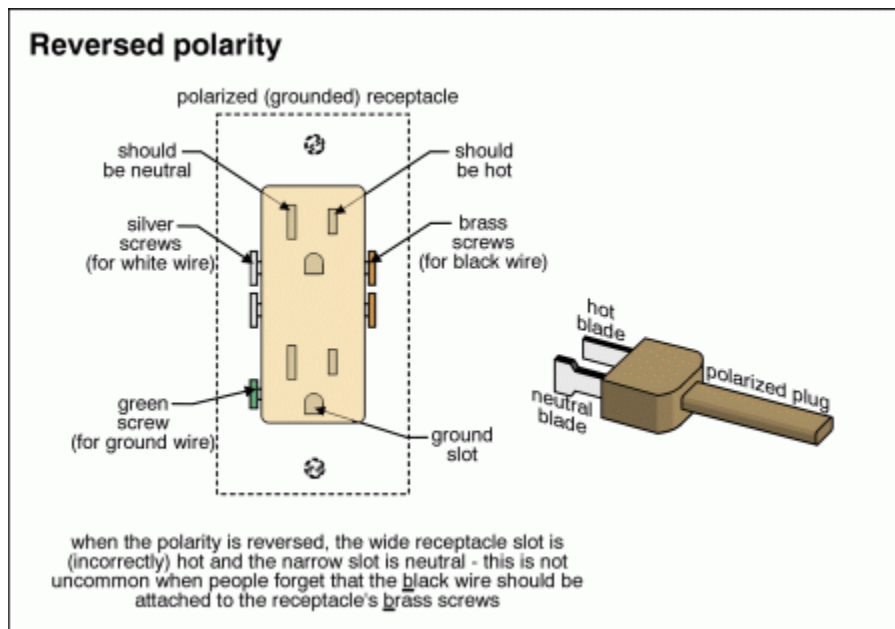
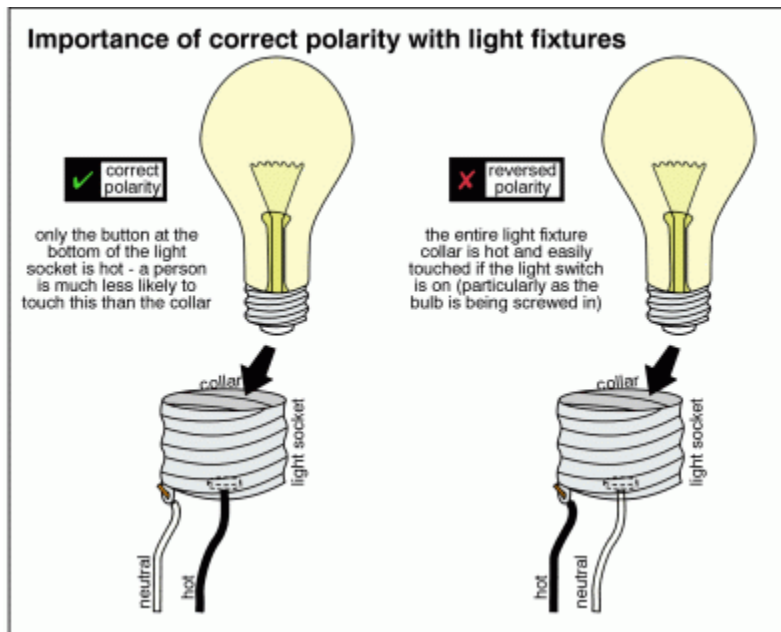
Distribution system \ Outlets

Condition: • [Reversed polarity](#)

Implication(s): Electric shock

Location: Basement Laundry area

Task: Repair

Time: Immediate

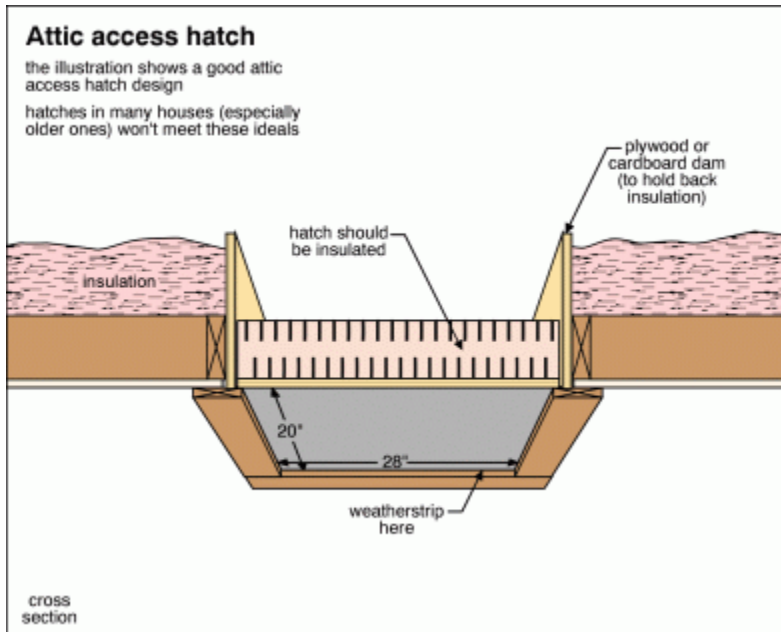
Attic/roof \ Hatch

Condition: • [Not insulated and not weatherstripped](#)

Implication(s): Chance of condensation damage to finishes and/or structure | Increased heating and cooling costs |

Reduced comfort

Location: Attic

Task: Improve

Time: Less than 1 year

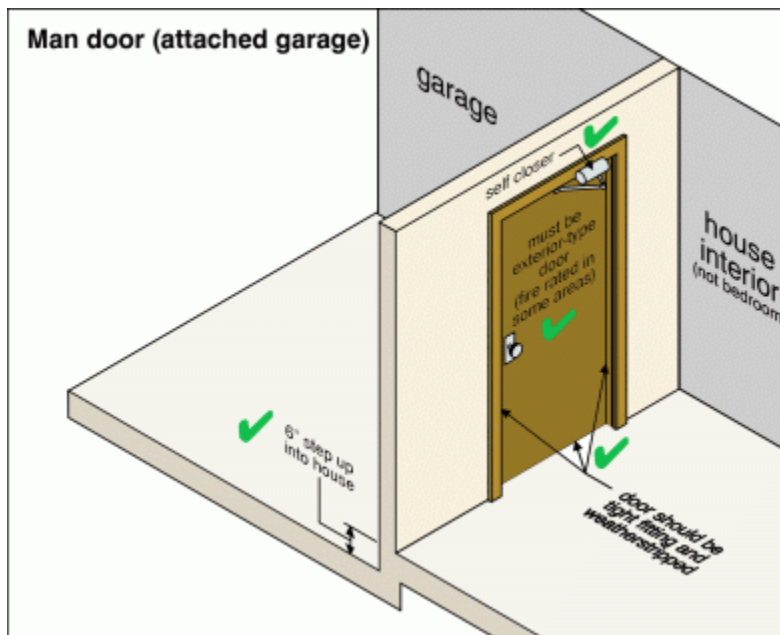
Garage \ Man-door into garage

Condition: • [Door not tight fitting and weather-stripped](#)

Implication(s): Hazardous combustion products entering home

Location: Basement Garage

Task: Repair or replace

Time: Less than 1 year

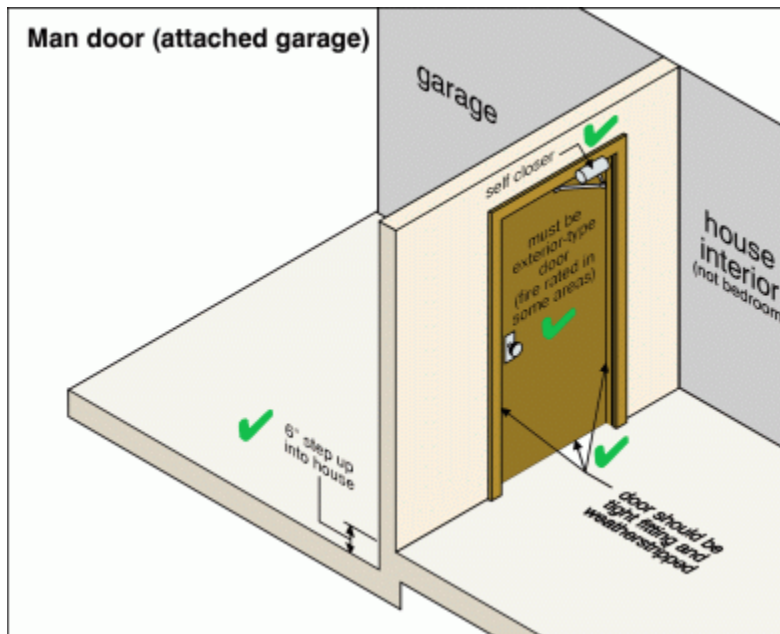
Garage \ Man-door into garage

Condition: • [No self closer](#)

Implication(s): Hazardous combustion products entering home

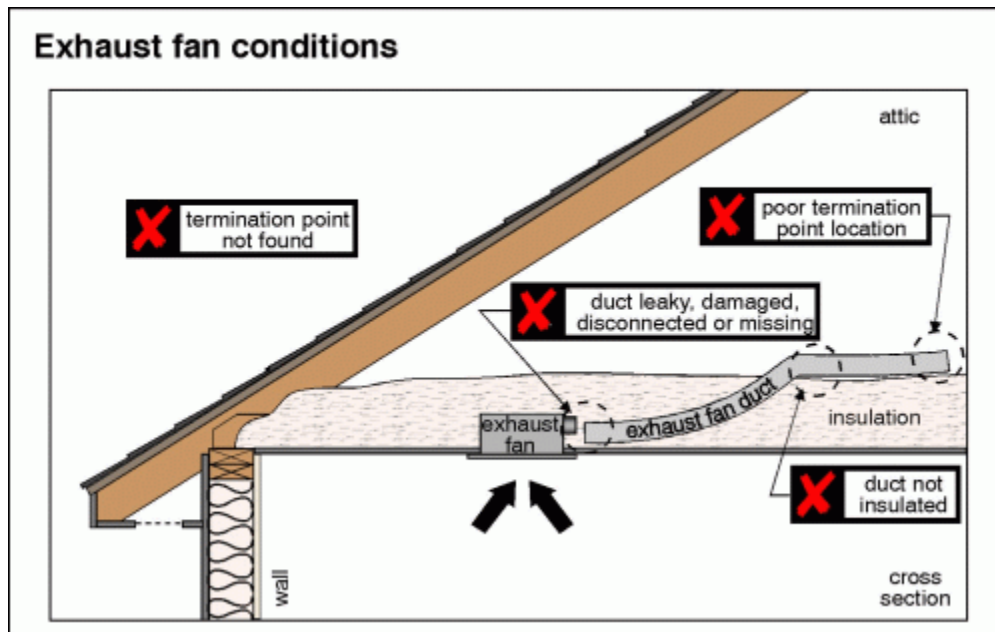
Exhaust fans \ Kitchen exhaust system

Condition: • Not vented to exterior

Implication(s): Chance of condensation damage to finishes and/or structure

Location: First floor Kitchen

Task: Improve

Time: Less than 1 year
